Verify and Troubleshoot Stackwise on Catalyst 9200/9300

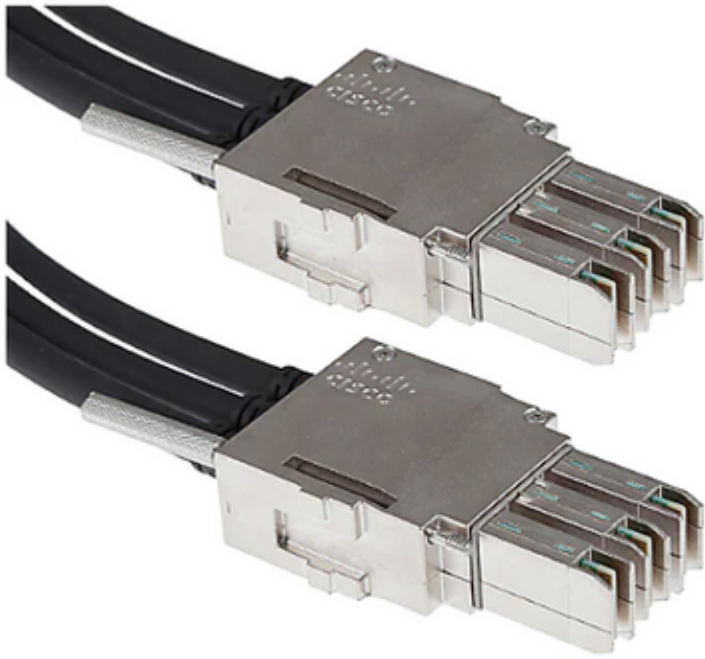
Stackwise-480 Cable Connection

With the C9300 stack kit STACK-T1-XXCM, the cables are manufactured in such a way that they are able to seat into the chassis upside-down. Ensure the Cisco logo faces upward, and that you are able to fully seat the thumbscrews to avoid incorrect installation.

Note: There is a Cisco logo that is milled into the metal. Ensure this logo is right side up and not upside down for proper installation.
