Troubleshooting uBR Cable Modems Not Coming Online

Document ID: 16510

Introduction

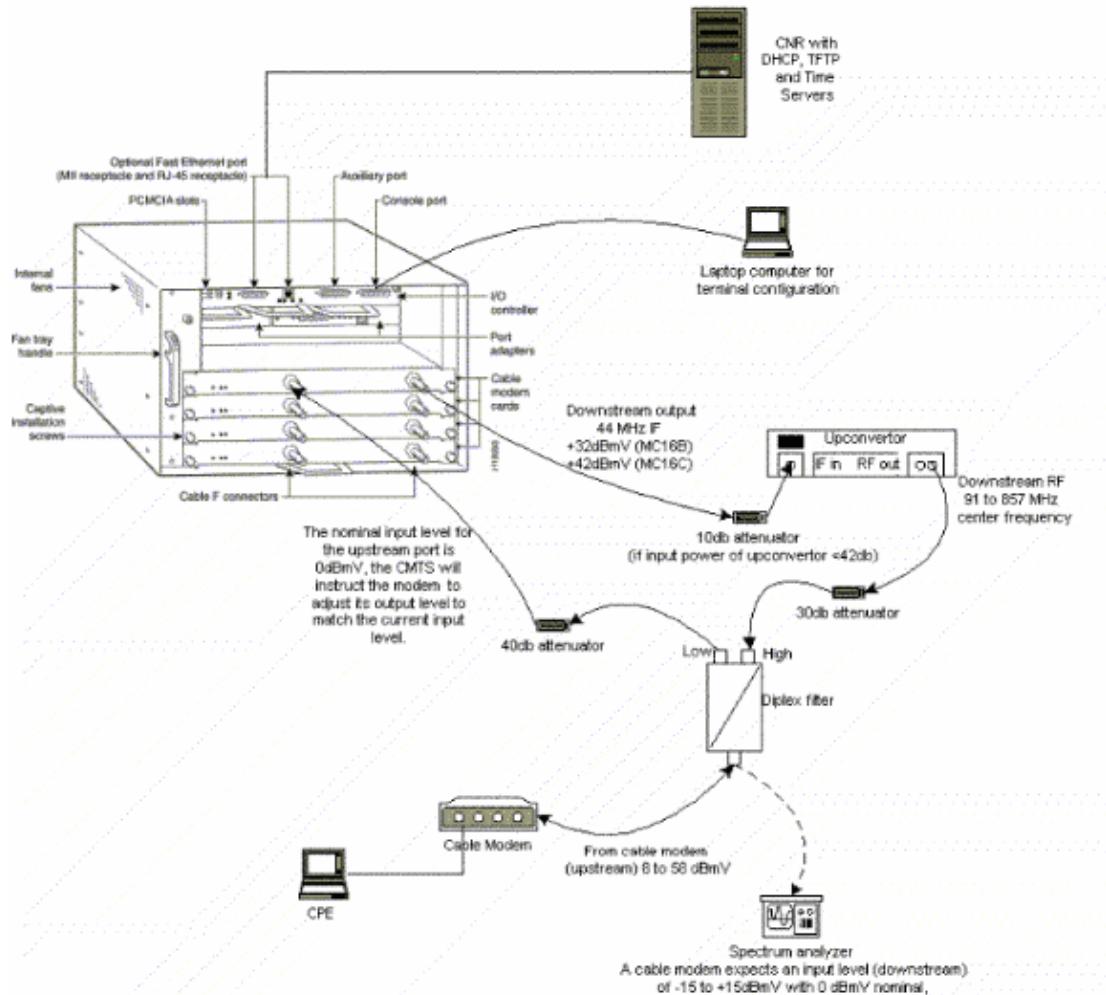
Note: Before starting to troubleshoot any state it is important to look at the state of all the Cable Modems to see whether or not this state applies to all the modems or just a few, and whether this is a new or existing network. If it is an existing network, then investigate any recent changes. In most parts of this document it is assumed that the problem affects all Cable Modems and the following lab topology is applicable:

The above setup can be used for troubleshooting purposes, and rules out RF issues, since this setup excludes Cable TV signals.

Note: The uBR7100 has an integrated upconverter so an external upconverter is not required. Refer to Setting the Integrated Upconverter for more information.

If a modem cannot proceed out of ranging state, the likely cause is an insufficient transmit power level. In the setup above transmit power can be adjusted by adjusting attenuation at the low frequency port. Increased attenuation will result in increased transmit power levels. Roughly 20 – 30 dB of attenuation is a good place to start. After initial ranging init(r1) the modem proceeds onto init(r2) which is where the modem must configure the transmit timing offset and power level to ensure that transmissions from the modem are received at the correct time and are at an acceptable input power level at the CMTS receiver. This is performed through a conversation of unicast RNG-REQ and RNG-RSP messages. The RNG-RSP messages contain power and timing offset corrections the modem must make. The modem continues to transmit RNG-REQ and perform adjustments per RNG-RSP until the RNG-RSP message indicates ranging success or ranging complete by reaching the init(rc) state. If a modem cannot proceed out of init (r2) the transmit power needs to be refined. Below is an output display of a CM in init(r2) state.
