# Troubleshooting ISDN BRI Layer 3 using the debug isdn q931 Command

Document ID: 9495

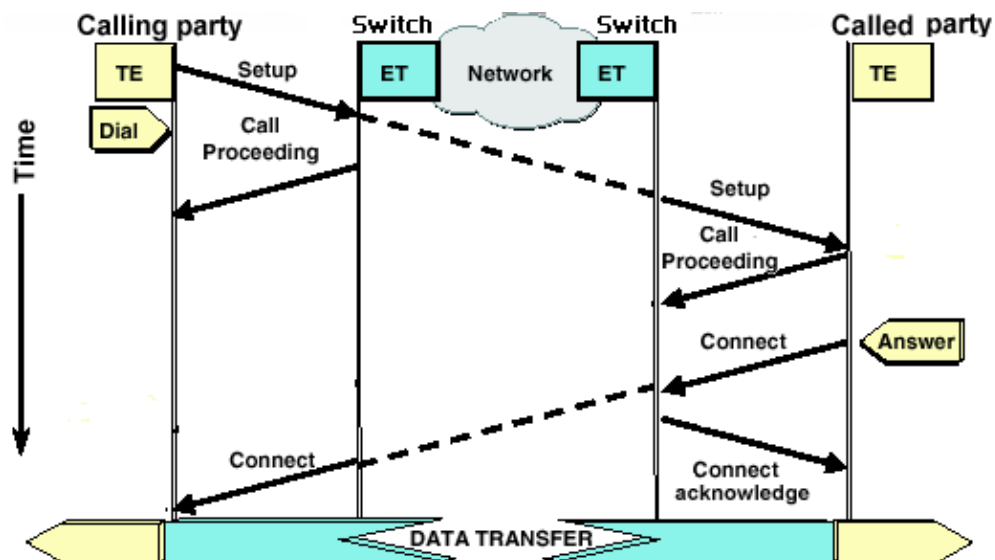
There can be many variations in the Q.931 exchanges due to specific requirements for ISDN switch types or in cases where additional parameters are required. The following diagram illustrates common Q.931 transactions during a successful ISDN call setup.

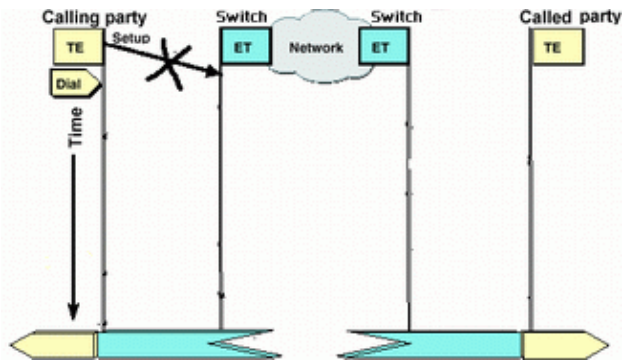
### The Calling Router does not send a SETUP message

If the Calling Router does not send a SETUP message to the ISDN network, the problem is likely related to ISDN layers 1, 2 or Dial-on-Demand Routing (DDR) issues, and is not layer 3 related

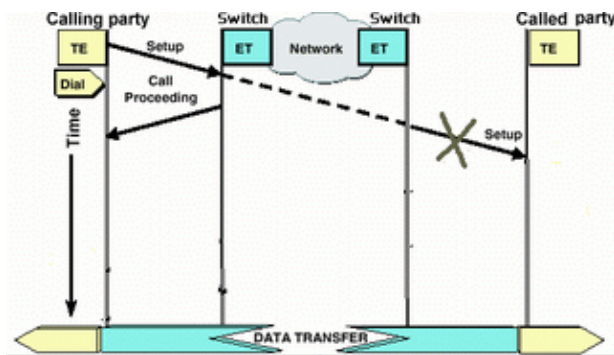
## The Called Router does not receive a SETUP message

If you determine that the Calling Router sends an ISDN Layer 3 SETUP message, but that the Called Router does not receive it, then the issue could be with ISDN layers 1 and 2 on the Called Router or it could be a problem with the telco ISDN cloud.

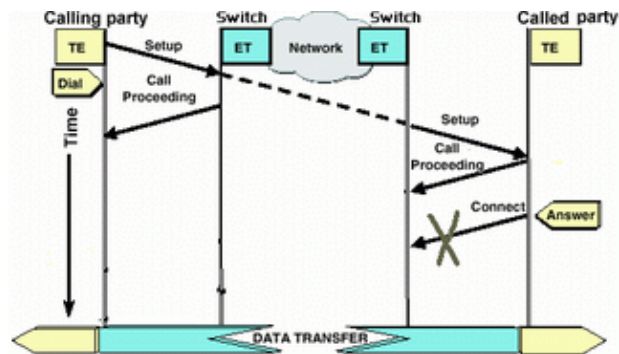
## The Called Router does not send a CONNECT message

If the Called Router receives a SETUP message but does not respond with a CONNECT message, then this could indicate that the router (for some undetermined reason) choose not to accept the call.

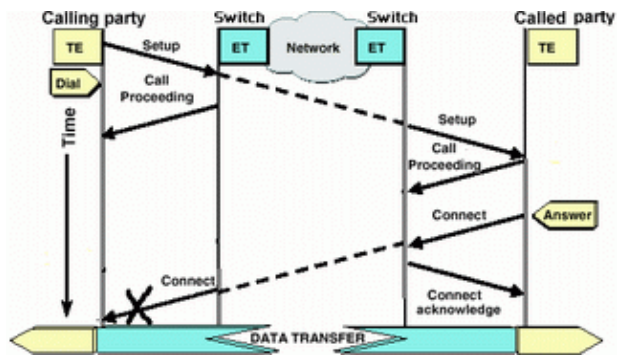
## The Calling Router does not receive a CONNECT message

If the Called Router sends a CONNECT message, but that message is not received by the Calling Router, then the issue most likely lies with the telco.
